PENJAJAWOC STREAM ANALYSIS AND INTERPRETATION

(FINAL REPORT)

Report to: Maine Department of Environmental Protection
Bureau of Land and Water Quality – Division of Watershed Management
17 State House Station
Augusta, Maine 04333-0017

Date: June 2006

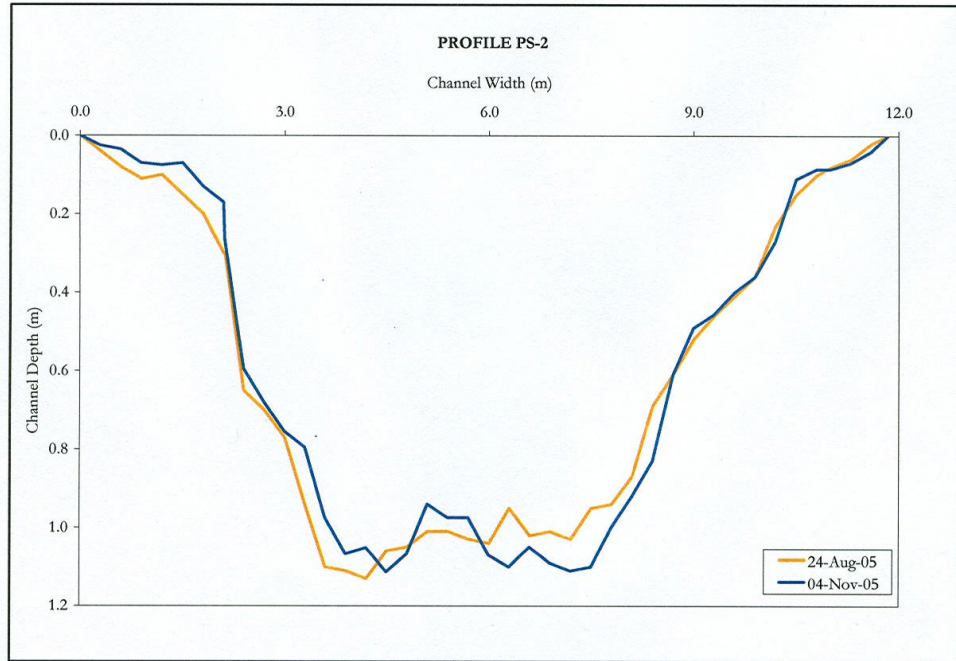
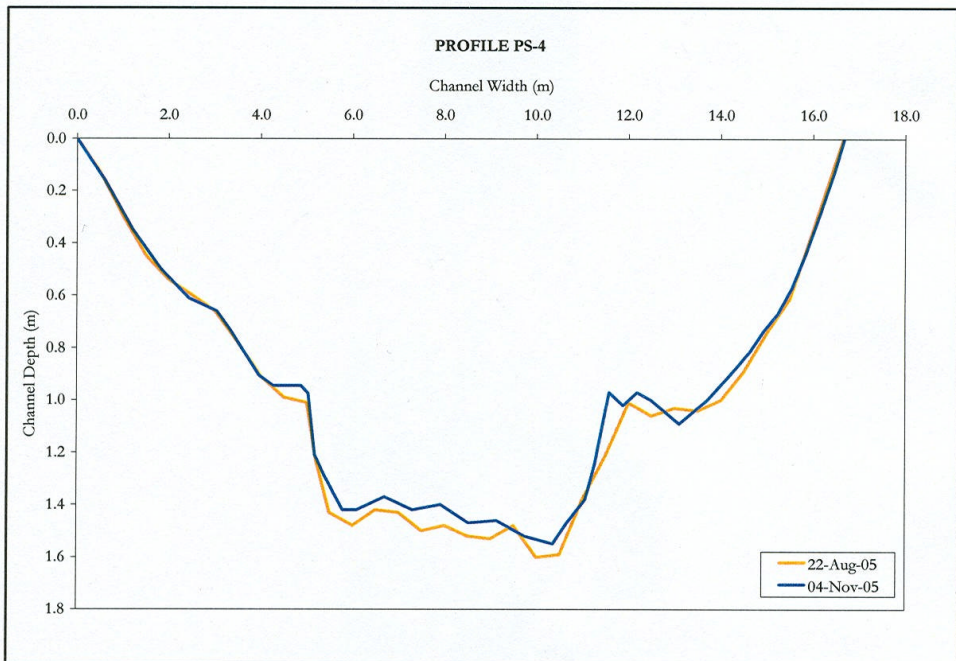
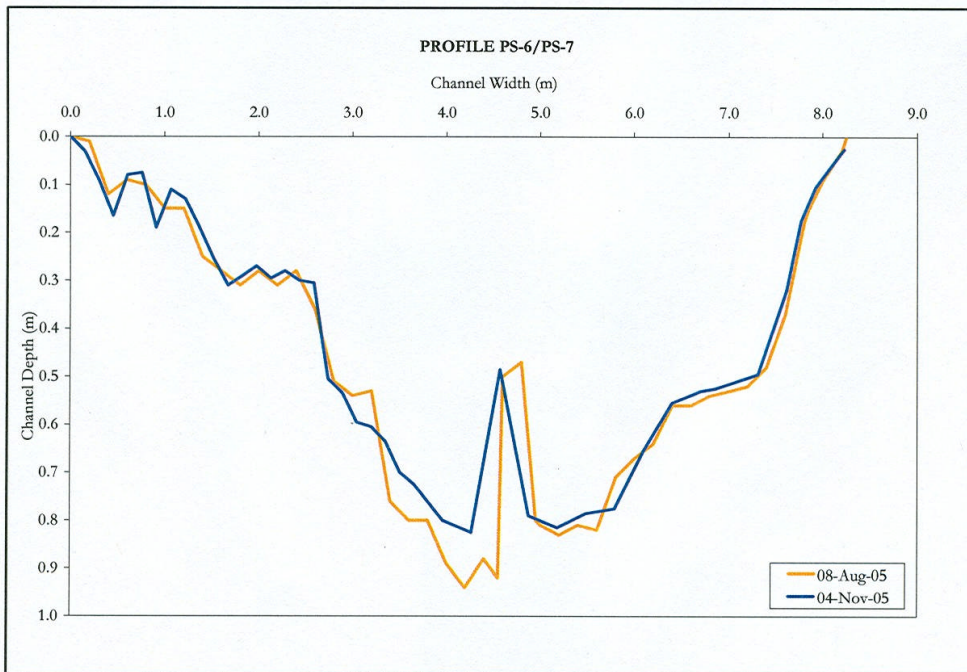
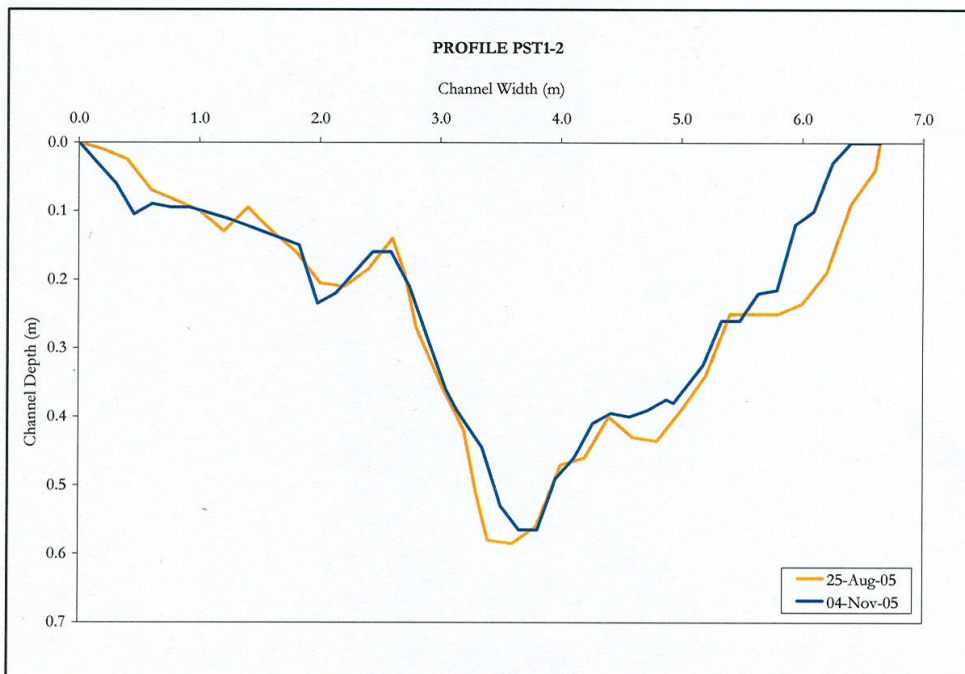
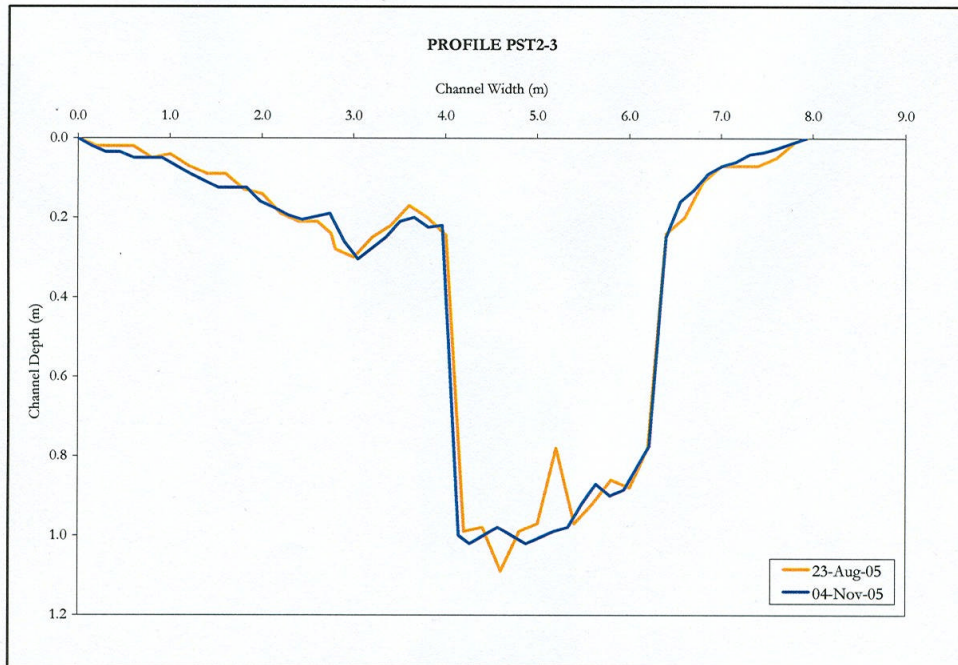
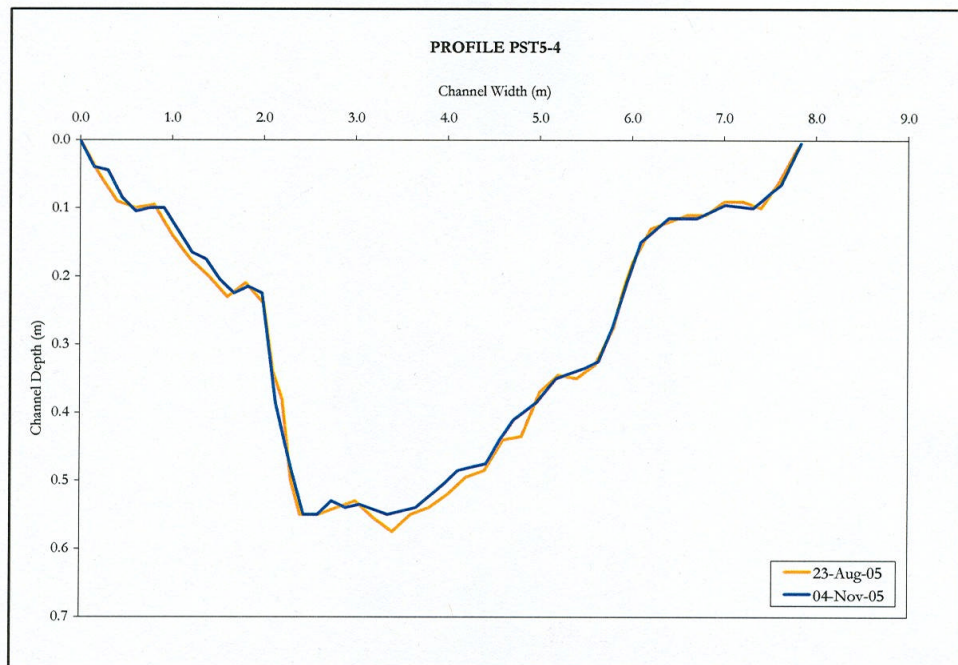
CHANGE IN CROSS SECTIONAL AREA

The percent change for monitoring cross section PS-2 was minimal, where only -0.19% change was recorded. A minor shift in bed material was noted in **Figure A** (in **Appendix A**) where sediment accumulation on the top and toe of the east bank, and degradation at the toe of the west bank was prominent. In general, the migration trend of cross section PS-2 is towards the west; however, it should be documented the change in cross sectional area may be attributed to human error due to fact the site was monitored by two separate teams. It is important to note that there was no change in erosion pin exposure for EP-2 located within the monitoring cross section.

Changes in cross sectional area for PS-4 resulted in a 0.76% loss, where only notable changes on the bed were observed. Bed aggradation was apparent, in addition to minor sediment accumulation on the banks. Overall, there were no major shifts within the monitoring cross

Results obtained from the cross sectional area assessment for cross section PS-6/PS-7 revealed a loss of 0.85%. Sediment accumulation was apparent in the center of the cross section, while evidence of aggradation and degradation of bank material was observed on the east bank. Based on the results obtained from the erosion pin assessment and the cross sectional area assessment indicate that no change in shape or form was observed along the west bank within this particular cross section.

Generally, cross section PST1-2 demonstrated the most change within the 3 month monitoring period, where a total cross sectional loss of 1.88% was recorded. Minor bank erosion was evident on the east bank, while the west bank experienced moderate sediment accumulation. As anticipated, the cross sectional shape of PST1-2 remained relatively consistent, where only a minor shift in material was noted. It is interesting to note that this site was deemed a “reference”, yet experienced change. This is likely indicative of the condition of the local channels end response to large flows.

Cross section PST2-3 was the only monitoring site which demonstrated a minor increase of 0.72% in area. The increase in area can be attributed to the loss of a large boulder which was present during the August 2005 monitoring. The loss of the boulder was assumed to have been forced downstream during high flows. Besides the minor fluctuations in sediment aggradation and degradation on the banks, it should be noted that the vertical banks did not experience any major changes; which is also reflected in the erosion pin assessment where a net loss of 0.12 in was measured between the August 2005 and November 2005 field reconnaissance.

Finally, cross section PST5-4 experienced a loss of 0.42%, where only a slight change in channel form was noted. As such, sediment aggradation at the west bank (toe of the bank) was observed, which is also evident in **Table 1** where EP-3 had a net increase of 0.79 in. Additional changes within cross section PST5-4 can be seen on the east bank where minor sediment accumulation on the top of the bank has resulted from bank slumping.
